# Sigma Tau MHM-A1 Lives Again

By Skip Withrow

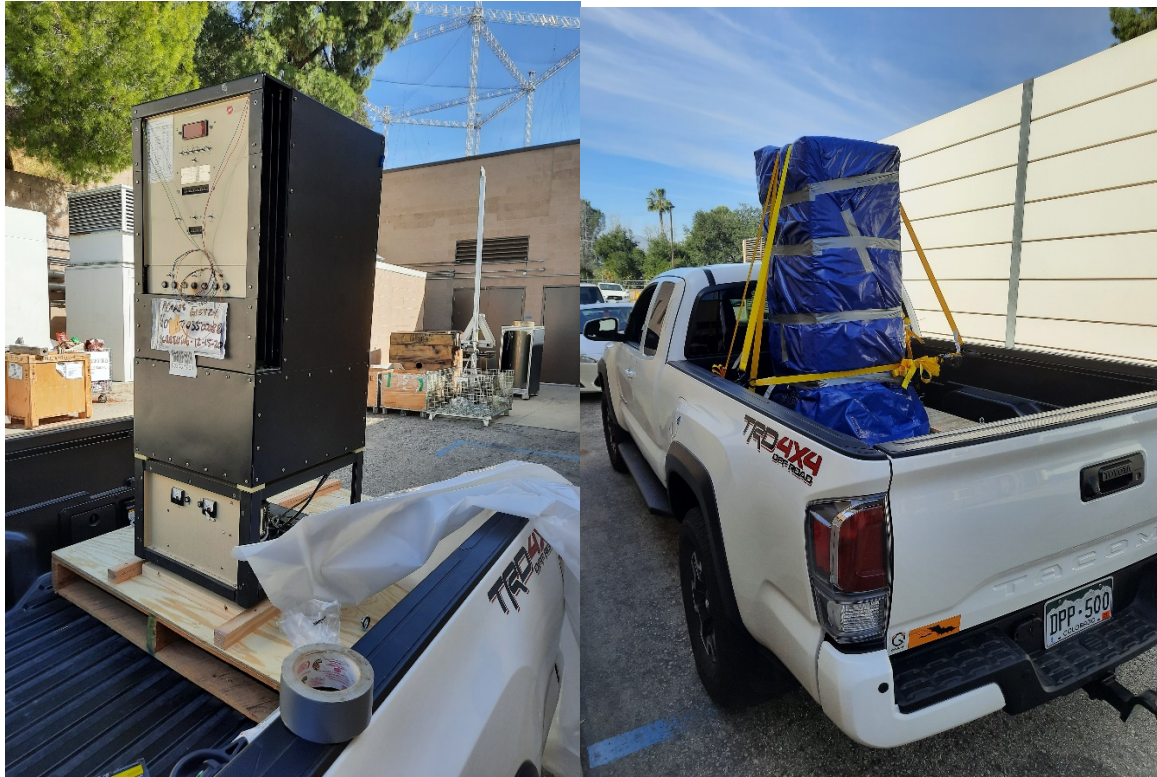
Photo 1 & 2 – MHM-A1 at JPL. You can see the wires hanging out the front, there was also a pot hanging out the back corner. It was palletized, wrapped in heavy plastic, packing blankets, and finally the blue tarp.

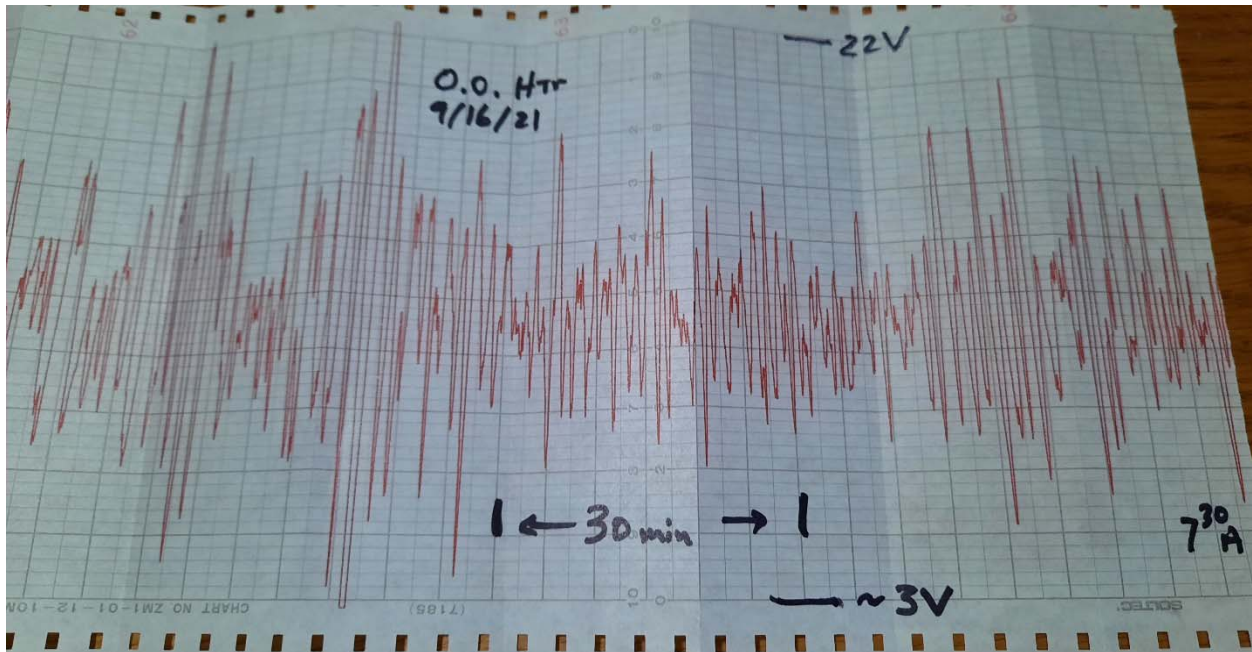
That is when I noticed the outer oven voltage doing strange things occasionally. My trusty chart recorder came in handy, and I discovered that the outer oven was intermittently (very) noisy. The worst of both worlds, intermittent and noisy. I chased this problem for at least a month. And finally came to the conclusion that the outer oven thermistor was noisy after lots of debug of the control amplifier. So, tore down the insulation and magnetic shield on the circumference to get to the thermistors and replaced them. Put it all back together and fired it up, nope, same problem. I should know better,

Photo 8 – This is not what you want to see when it comes to maser temperature control.

always open the loop to debug a closed loop system. So, after another debug session found that there is a power driver amplifier mounted in another part of the maser. Indeed, that is where the noisy component resided. JPL would have never found the problem with their trimpot hanging out the side of the unit as they were debugging closed loop as well.

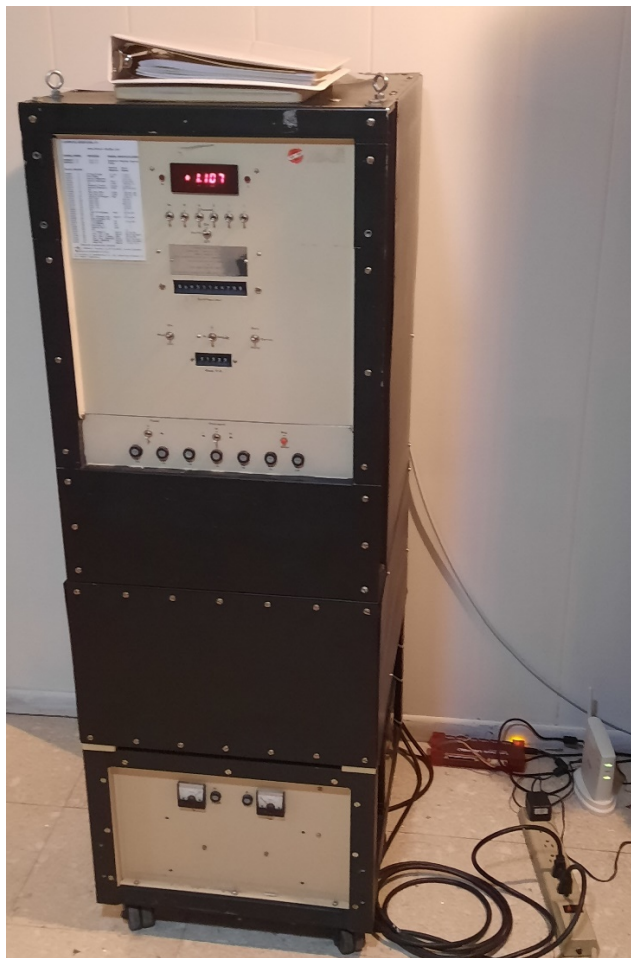
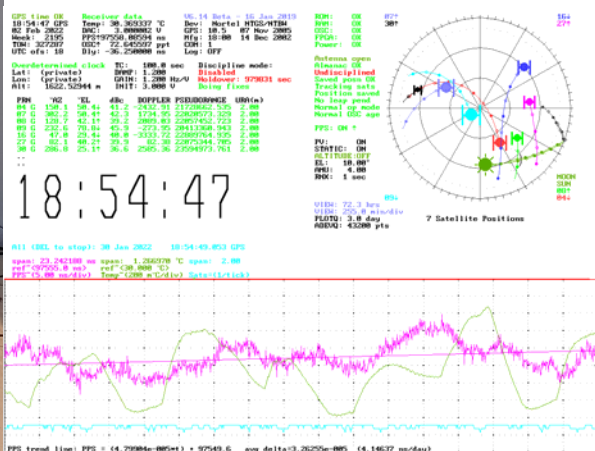
Photo 11 & Chart 1 – MHM-A1 is running again. Still a few screws to put in the covers. Have it running about 4ns slow over three days a little more than a week after first cavity register LOCK.

At this point I hooked up a GPS frequency monitoring system for the first time and was surprised that the frequency was much closer than I expected. After letting it run overnight the maser measured -4.0x10E-13 slow. An appropriate adjustment was made to the synthesizer to get it closer to being on frequency.
